# Reduction of Scrap in an Electronic Assembly Line Using DMAIC Approach

Afzal Matathil<sup>1</sup>, Ganapathi K. N.<sup>2</sup>, Kalathil Ramachandran<sup>3</sup>

1- M. Sc. [Engg.] Student, 2-Asst.Professor,  
Mechanical and Manufacturing Engineering, MSRSAS, Bangalore 560 058.  
3-Manager-QA, Sanmina-SCI, Chennai

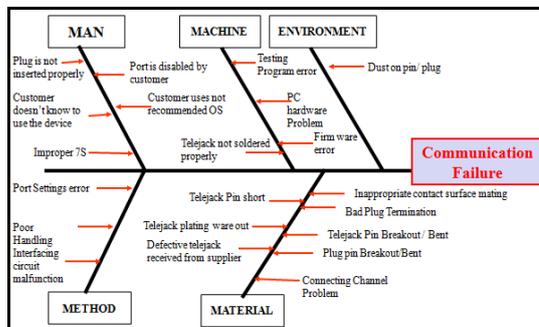
Fig. 4 Fish bone diagram

Brainstorming session had been conducted to understand possible causes for “communication failure”. Brainstorming is done by the cross functional team participating production, testing, design, quality, process and finance departments. The figure below illustrates possible causes found in brainstorming session.

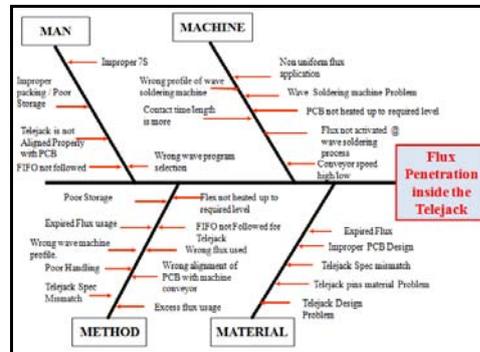
**Fig. 6 Fish bone diagram Flux penetration inside the telejack**

Further brainstorming session has been conducted to find out the possible causes for “Flux penetration inside the telejack”. Production, NPD, process, purchase, and Quality representatives have been attended the session. The figure below illustrates possible causes for “Flux penetration inside the telejack”.

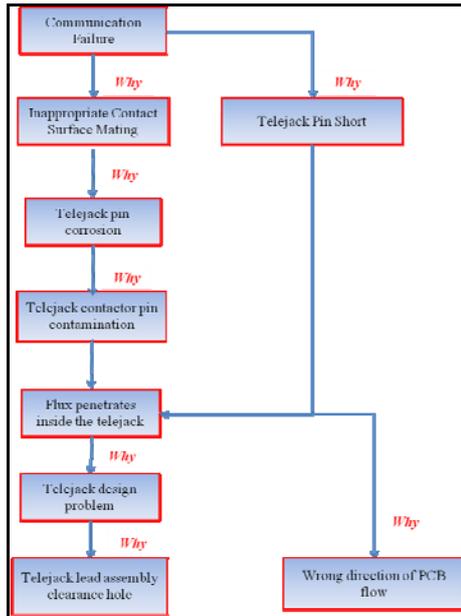
**Fig. 7 Why-why analysis**

The why- why analysis below illustrates how “clearance hole” eventually caused in the communication failure.

The root cause had been confirmed after covering each telejack leads by a stiffener and by checking each with microscope for the flux penetration after the wave soldering process. Found that the flux penetration has been completely eliminated for the sample of 100. So, from the detailed analysis, it has been concluded that root cause for the communication failure are “Telejack Lead Assembly Clearance Hole” and “Wrong direction of PCB flow”

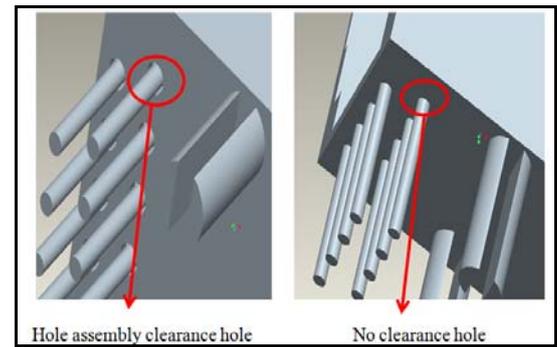
**Fig. 8 Telejack design old and proposed**

The clearance hole has been defined and specified on the telejack specification sheet. A new design of telejack has been proposed for designer approval. The

diagram below shows current and proposed design of telejack.

- Pin clearance hole has been specified and defined in the telejack data sheet. As per the new drawing, no clearance hole allowed.
- Circular shaped pins are modified into square.
- The diameter of the pin has been modified from 0.9mm diameter into 0.89 diagonal lengths.

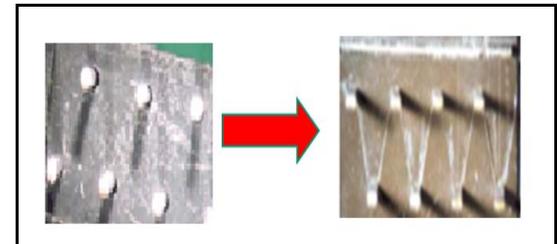
**Fig. 9 Telejack old and new**

As the new proposed design send to the design team situated at U.S.A, The proposed design has been approved with minor modification. The approved design has square leads instead of circular shape with diameter reduction of 0.1 mm. The figure below shows actual photos of old and new telejack.
