Reduction of Scrap in an Electronic Assembly Line Using DMAIC Approach

Afzal Matathil¹, Ganapathi K. N.², Kalathil Ramachandran³

1- M. Sc. [Engg.] Student, 2-Asst.Professor,
Mechanical and Manufacturing Engineering, MSRSAS, Bangalore 560 058.
3-Manager-QA, Sanmina-SCI, Chennai

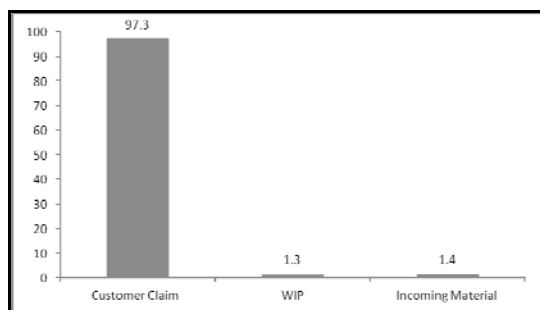
Fig. 1 Bar graph for scrap distribution

From the figure 1, bar graph above, it could be understood that 97% of total scrap cost is due to customer claim, 1.3% is contributed by WIP scrap and remaining 1.4% is caused by incoming material defects. Hence, as the most contributing group, this study concentrates on reduction of scrap generated through customer claim.

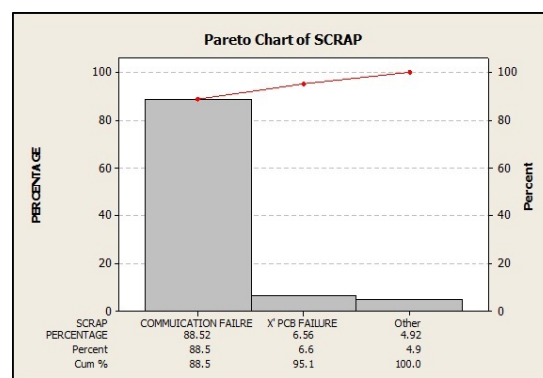
Fig. 2 Pareto on customer claimed scraps

The figure 2 reveals that 88.52% of the total scrap cost is due to communication failure. And 6.52% is due to CC PCB failure and remaining costs are due to various other factors. **Hence for this project, communication failure has been selected.** Resolving this problem would reduce 85% of the total scrap cost.

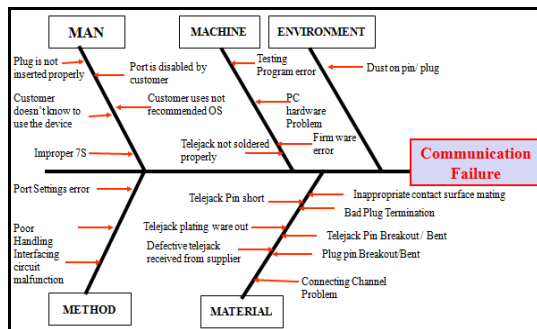
Fig. 4 Fish bone diagram

Brainstorming session had been conducted to understand possible causes for “communication failure”. Brainstorming is done by the cross functional team participating production, testing, design, quality, process and finance departments. The figure below illustrates possible causes found in brainstorming session.

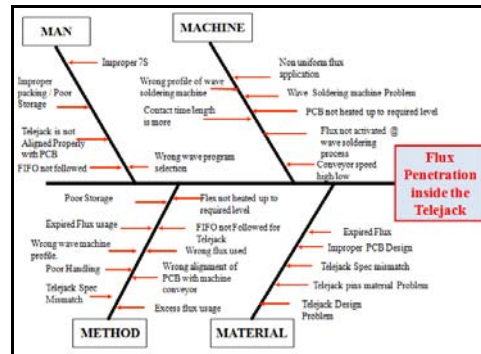
Fig. 6 Fish bone diagram Flux penetration inside the telejack

Further brainstorming session has been conducted to find out the possible causes for “Flux penetration inside the telejack”. Production, NPD, process, purchase, and Quality representatives have been attended the session. The figure below illustrates possible causes for “Flux penetration inside the telejack”.

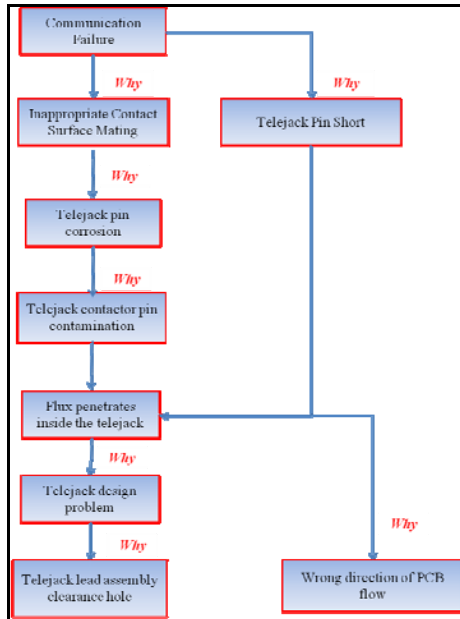
Fig. 7 Why-why analysis

The why- why analysis below illustrates how “clearance hole” eventually caused in the communication failure.

The root cause had been confirmed after covering each telejack leads by a stiffener and by checking each with microscope for the flux penetration after the wave soldering process. Found that the flux penetration has been completely eliminated for the sample of 100. So, from the detailed analysis, it has been concluded that root cause for the communication failure are “Telejack Lead Assembly Clearance Hole” and “Wrong direction of PCB flow”

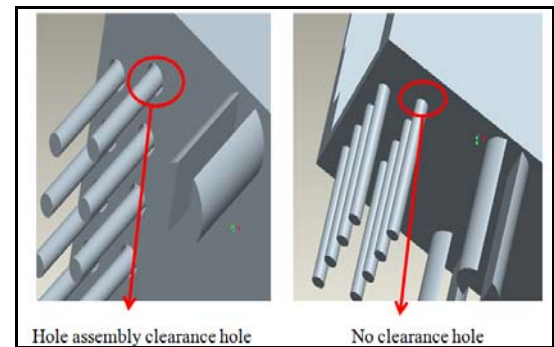
Fig. 8 Telejack design old and proposed

The clearance hole has been defined and specified on the telejack specification sheet. A new design of telejack has been proposed for designer approval. The

As the new proposed design send to the design team situated at U.S.A, The proposed design has been approved with minor modification. The approved design has square leads instead of circular shape with diameter reduction of 0.1 mm. The figure below shows actual photos of old and new telejack.
